Lawrence Livermore National Laboratory
Experimental Test Site 300

Compliance Monitoring Program for the
Closed Building 829 Facility

Annual Report
2010

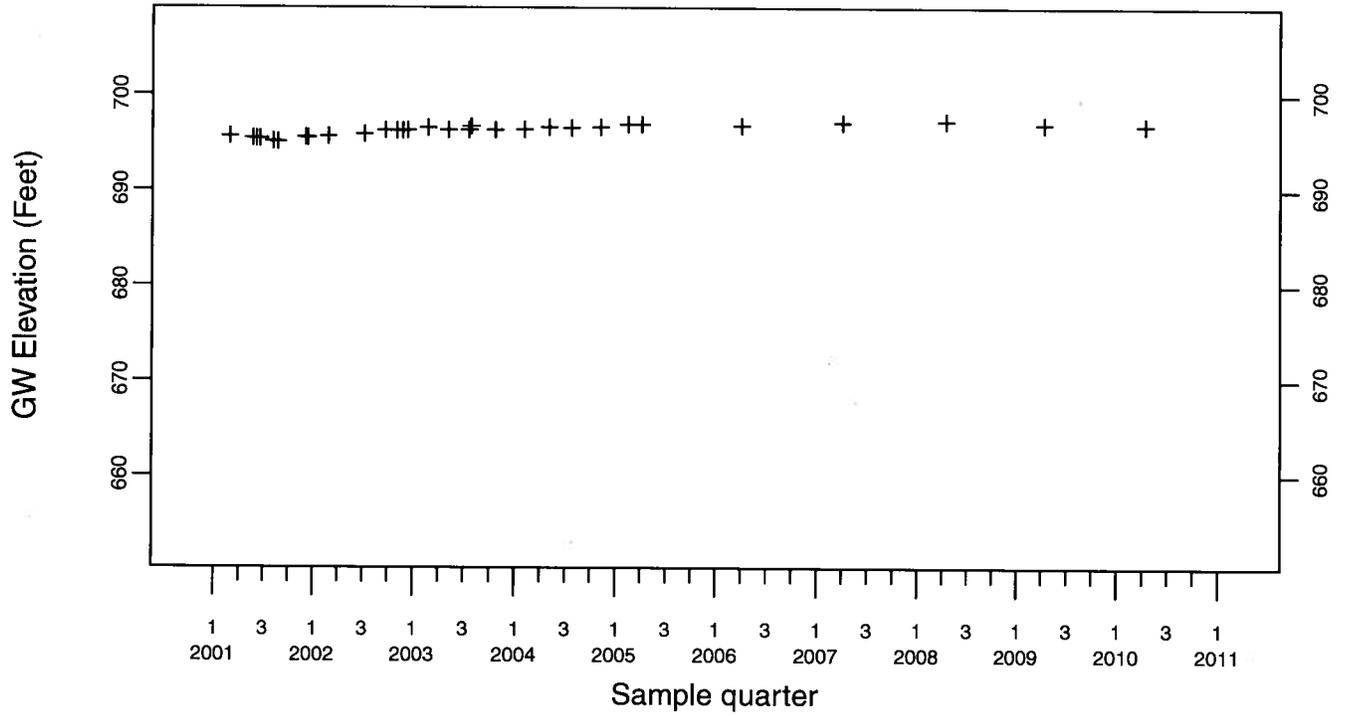
Monitoring Point W-829-15

Building 829 GW Elevation (Feet)

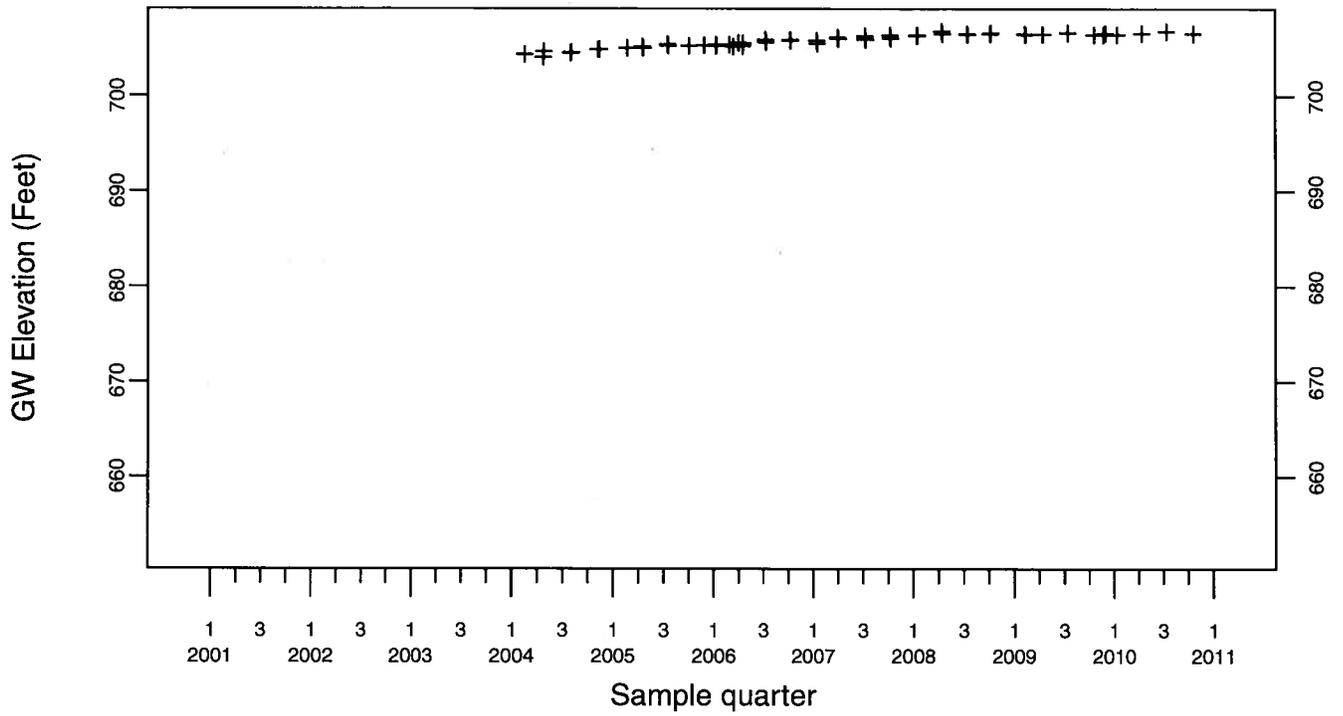
Monitoring Point W-829-1938

Building 829 GW Elevation (Feet)

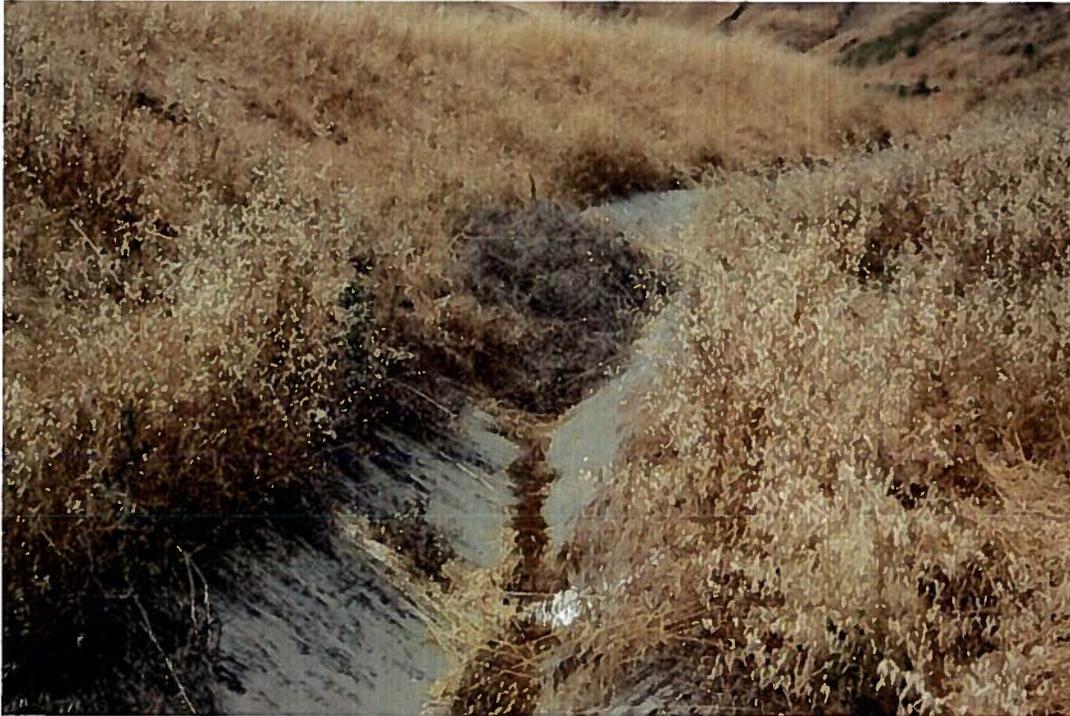
Figure 7 Building 829 Vegetative Debris Accumulation and Growth in Concrete Drainage Ditch

Surface runoff diversion structures consist of a perimeter drainage V-ditch. The V-ditch has expansion joints every 12 ft and every other one is caulked. The remaining expansion joints appear to be saw cuts partially onto the surface of the concrete. The structure also collects water from the "drainage layer" of the cap through a series of drainage pipes. Concrete lining appears to be in good condition. Evidence of vegetation growth and debris accumulation in the drainage ditch were observed, see Figure 7. It is recommended that vegetative debris and growth be removed and cracks in the concrete ditch sealed as necessary.

- Repair the cracks on the west side of the cap.
- Remove vegetative debris from the drainage ditch.
- Remove vegetative growth from the drainage ditch and repair cracks as necessary.
