UCRL-AR-143121-14

Lawrence Livermore National Laboratory
Experimental Test Site 300

Compliance Monitoring Program for the
Closed Building 829 Facility

Annual Report
2014

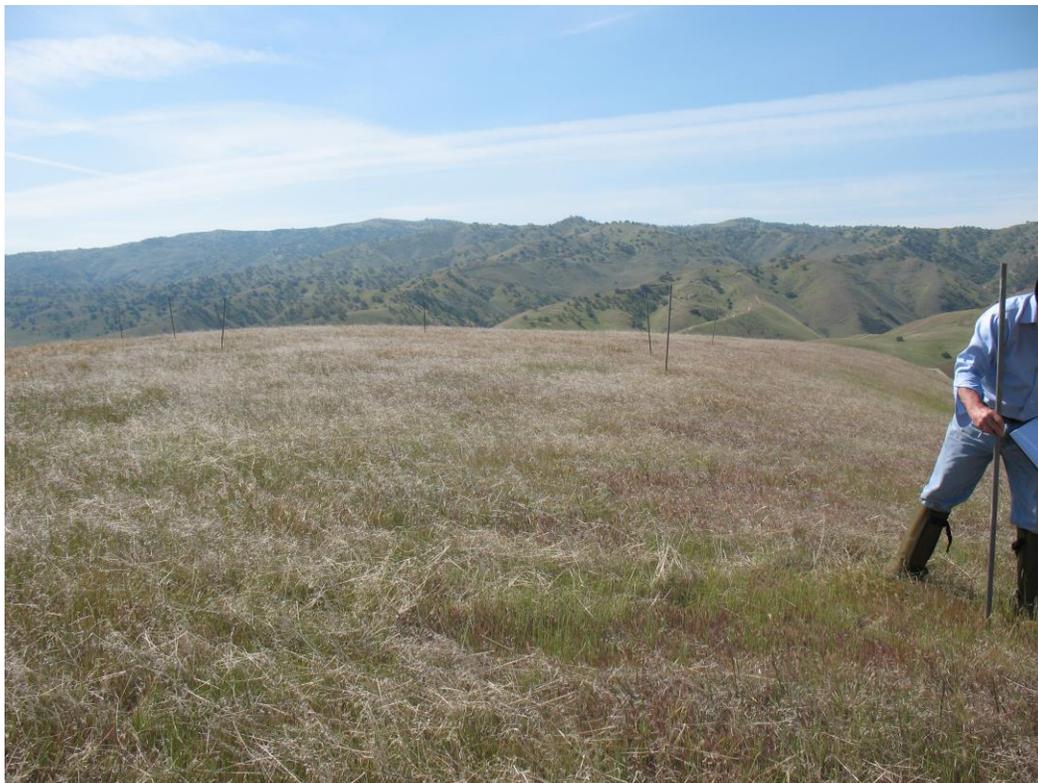
Figure 4 Building 829 Landfill Vegetation Cover Condition

Building 829 Landfill cap is in good condition. The vegetation cover is thick and covers the soil cap over the pits; there is no visible erosion of the cap; and the drainage system is in good condition and appears to be functioning as intended. The groundwater monitoring system appears to be in good condition as well. Some vegetation growth and vegetative debris were observed in the concrete lined drainage ditch. Recommendations for the observations are made in section 2-14

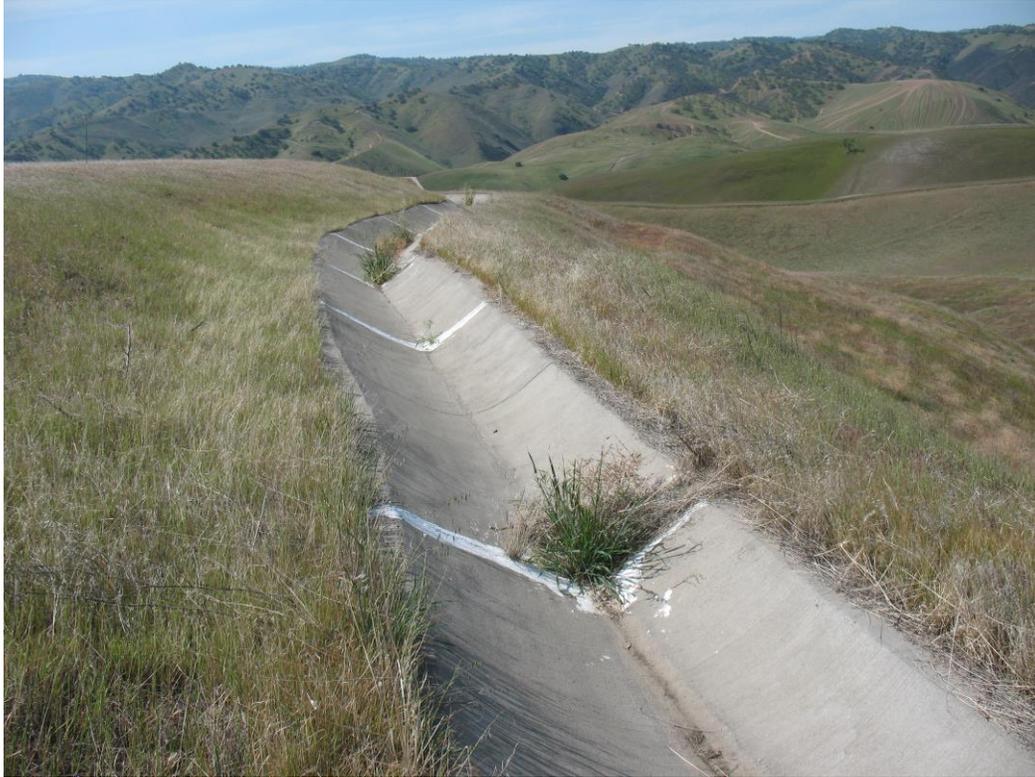
Figure 5 Building 829 Landfill Vegetation Growth in Drainage Ditch

Surface runoff diversion structures consist of a perimeter drainage V-ditch. The V-ditch has expansion joints every 12 ft and every other one is caulked. The remaining expansion joints appear to be saw cuts partially onto the surface of the concrete. The structure also collects water from the "drainage layer" of the cap through a series of drainage pipes. The concrete lining appears to be in good condition. Some vegetation growth, see Figure 5, and vegetative debris, see Figure 6, were observed in the concrete lined drainage ditch. It is recommended that the vegetative debris and growth be removed and the joints sealed.

- Remove vegetative growth and debris. Seal concrete joints.

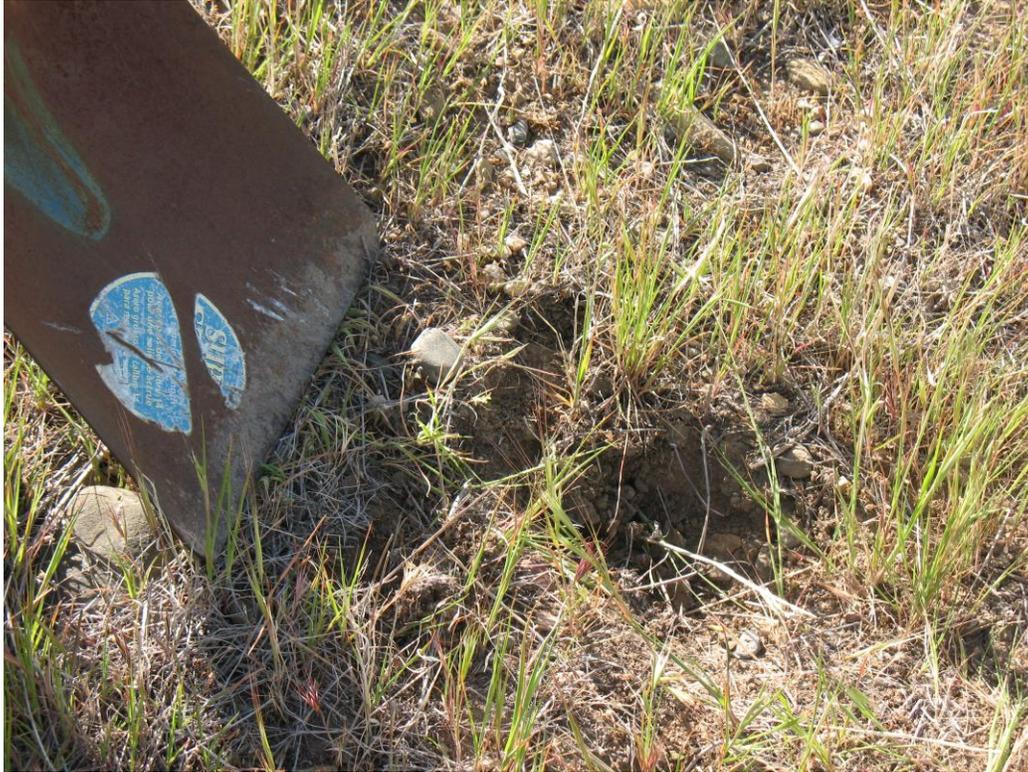
Figure 7 Building 829 Landfill Burrowing Animal Hole

A few shallow small burrowing animal holes, approximately 6 inches in diameter were observed, see figure 7. The animal holes were repaired as they were found.
